Hurricane Katrina: Geotechnical Observations in Biloxi, Mississippi

Dante Fratta, Craig C. Schuettpelz and J. Carlos Santamarina

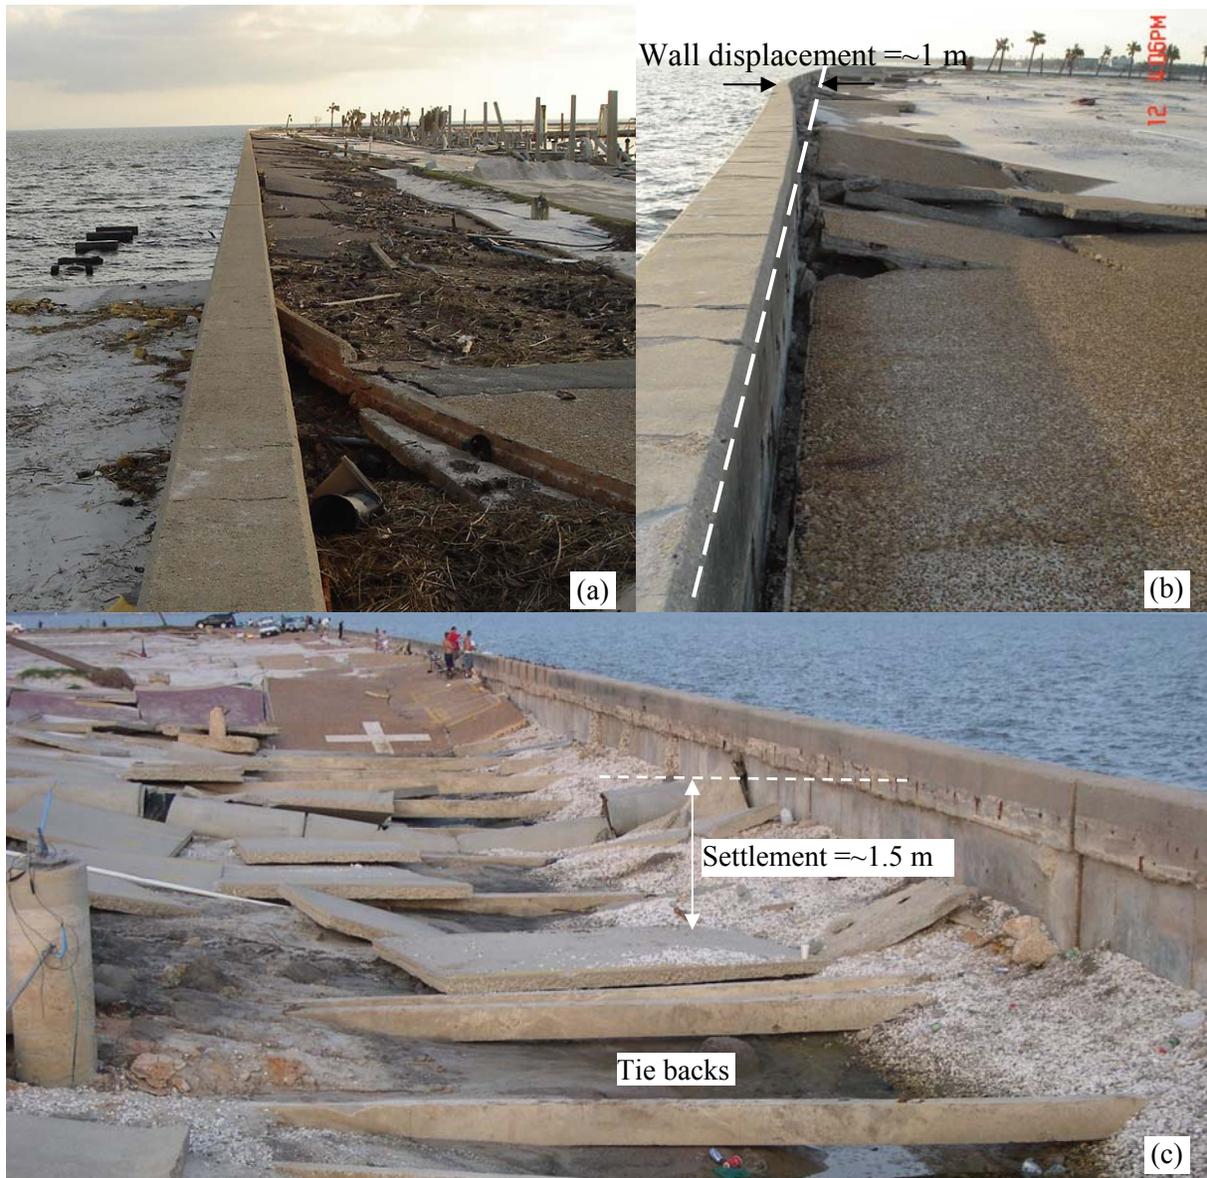
The top of the wall is 2.5 m above mean sea level. The retaining wall normal to the shoreline suffered some erosion and undermining of the concrete road that runs parallel to the wall (up to 0.7 m settlement), however, the wall itself shows no sign of distress. On the other hand, the front wall parallel to the shoreline rotated more than 1m towards the water and there is extensive erosion of the backfill (more than 1 m deep). The reinforced concrete tiebacks are fully exposed, and some have severed (Figure 1). Therefore, the failure mechanism combines the effects of backfill erosion, reduced tieback resistance and seepage forces.

Figure 1: Retaining wall failure in the Broadwater Beach Marina. (a) The 450-m long east retaining wall suffered no damage; however, the fill under the pavement eroded and the pavement settled about 0.7 m. (b) The 240-m south retaining wall rotated more than 1.0 m towards the Gulf of Mexico. (c) The backfill for the south wall eroded, the pavement settled and the tie backs failed.

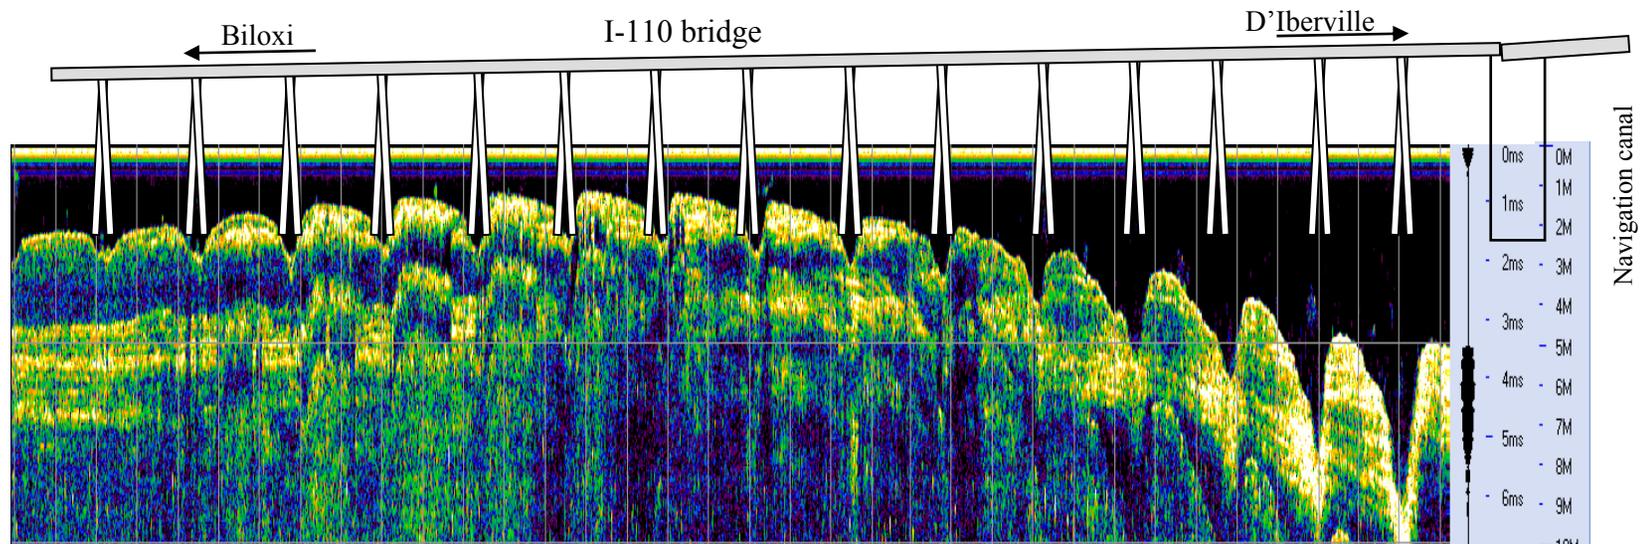
Clear scour is observed at every pile set, as can be seen in Figure 2 for the case of the I-110 bridge. Erosion takes place all around the pier, yet it is more pronounced on the side of the incoming surge.

The sediments in the Bay of Biloxi consist of a plastic green, organic mud with traces of sand. This soft mud traps gas, and it is often found overlaying oyster beds. Trapped gas and shells reduce the penetration depth of the subbottom profiler, and "shadows" appear in the cross section, as can be seen in Figure 2.

We found finer sediments near Highway 90 ($D_{50}=0.01$; LL=80, PL \sim 25) than around the I-110 bridge ($D_{50}=0.06$ mm; LL=34, PL \sim 25). This is reflected in the depth of erosion wells which are deeper for the I-110 bridge (up to 3.5 m) than along the Highway 90 bridge (up to 1.5 m), even though the Highway 90 bridge was more exposed to the storm (the estimated peak flow velocity is very similar in both cases - $V_{\text{flow}}\approx 0.27$ m/s). Erosion analyses support this observations (for example, see Graf 1984): spherical particles size $D_{50}=0.06$ mm (near I-110 bridge) can be eroded when the flow velocity exceeds 0.25 m/s, while particles size $D_{50}=0.01$ mm (near Highway 90 bridge) require a flow velocity of 0.60 m/s to be eroded.

Figure 2: 20 kHz subbottom profiles of Bay of Biloxi Bridges. (a) Collapsed Highway 90 bridge. The profile was run approximately 1.5 m from the SE edge of the pile sets, the average separation between pile sets is 16 m. (b) I-110 Bridge. The profile was run approximately 1.5 m from the E edge of the pile sets, the average separation between pile sets is 30 m. Horizontal scales are different.

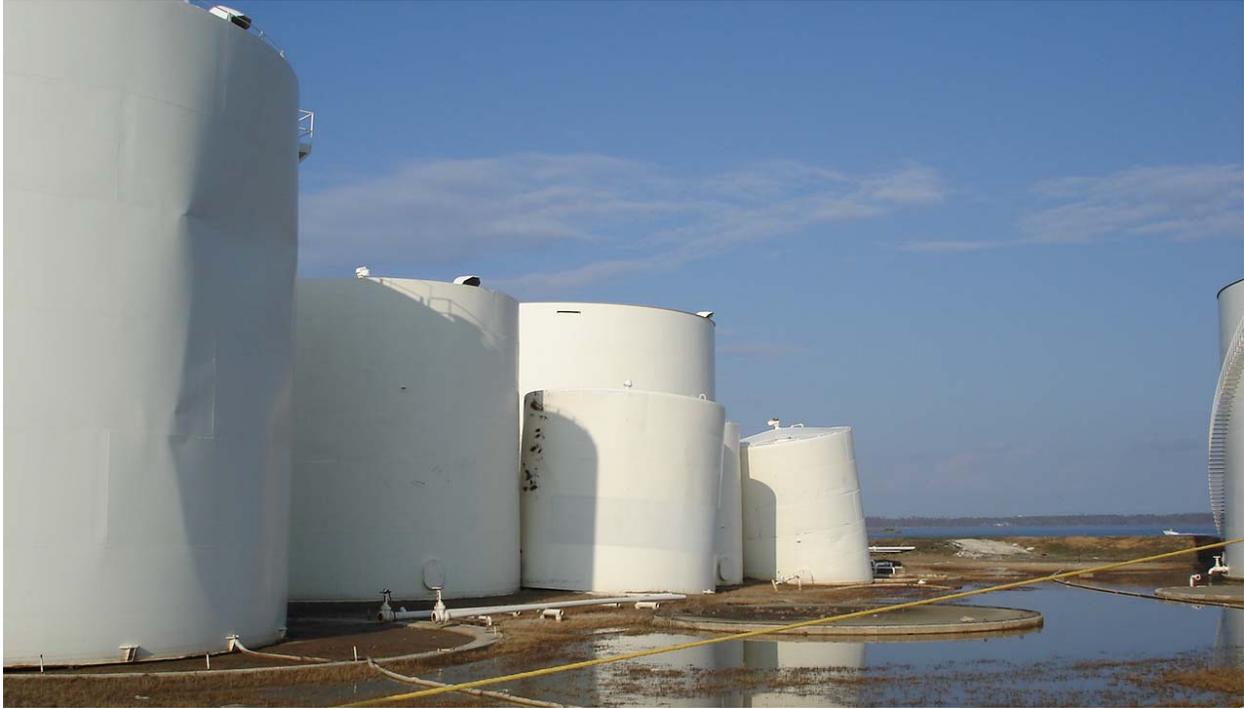
Oil tanks that were not sufficiently filled at the time of the storm surge were lifted from the foundation shearing anchor bolts, and floated away sometimes above the peripheral embankment designed for spill containment (Figure 3 – see also Godoy et al 2006).

Figure 3: Displaced oil tanks at the Munro MP Terminal in Biloxi. Some tanks were displaced more than 40 m and even crossed the spill controlled embankment built around the tanks.

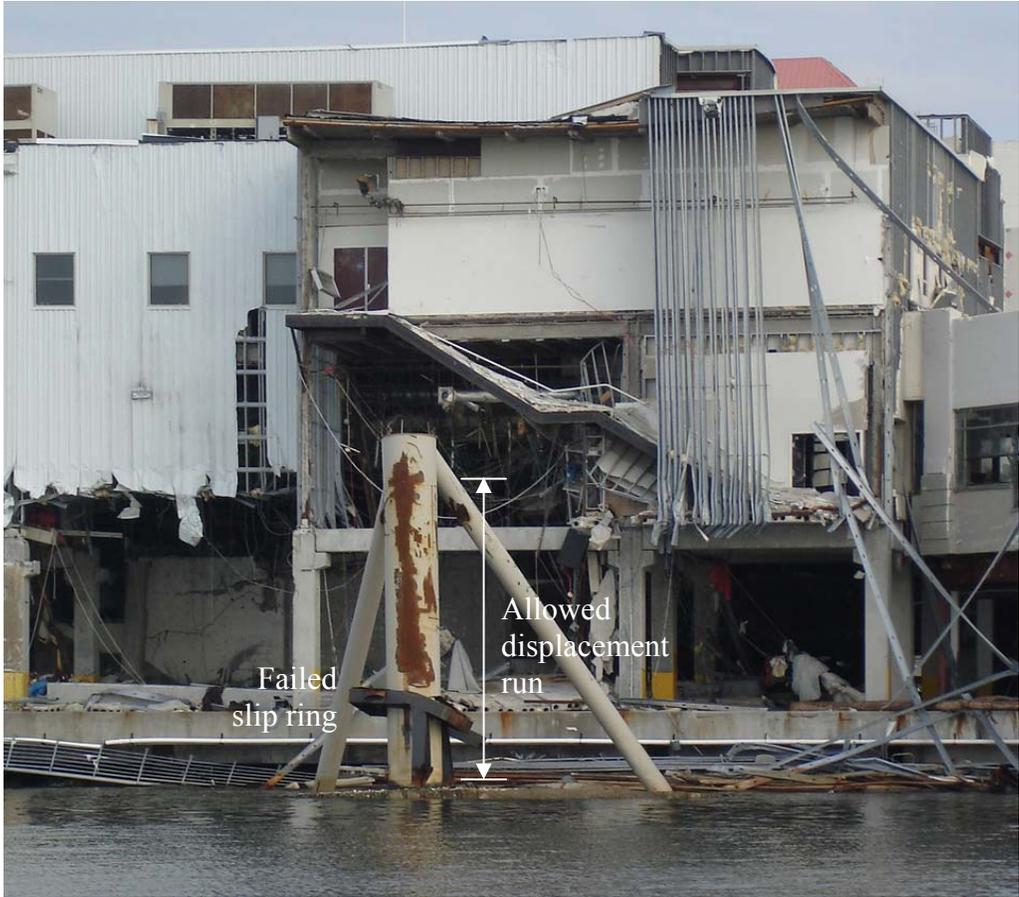
Several casinos were housed on floating barges (typical dimensions: 200 m long, 40 m wide and 5 stories tall). These barges were kept in place with either of two designs. Most barges used slip rings to slide up-and-down steel shafts following the tides. In this case, while the shafts did not fail, rings reached the end of the allowed ~4 m run during the hurricane, and sheared from the barges (Figure 4). The freed barges floated away (more than a 1000 m in the case of the President Casino). The other design, used in the Beau Rivage y Hard Rock casinos consisted of keeping the barge in position with 20 to 30 m long tension piles. The Beau Rivage casino suffered minor damage (no apparent foundation damage), while the Hard Rock casino was destroyed (we have not been able to gather information about the foundation performance).

Figure 4: Anchor system and failed slip rings of the Grand Casino barge.
